Test specimen:	Specimen:	Colour:	Client reference number:
	B.	Rouse	MAGMA MATRAS densiteit 35kg/m ³

Examination:	Testnumber:	Testname:
	1.	FIRE TESTS ACCORDING TO BS EN 597-1:1995 ASSESSMENT OF THE IGNITABILITY OF MATTRESSES AND UPHOLSTERED BED BASES (Part 1: Ignition source: smouldering cigarette)
	2.	FIRE TESTS ACCORDING TO BS EN 597-2:1995 ASSESSMENT OF THE IGNITABILITY OF MATTRESSES AND UPHOLSTERED BED BASES (Part 2: Ignition source: match flame equivalent)
	3.	FIRE TESTS ACCORDING TO BS6807: 2006 (Methods of test for assessment of the ignitability of mattresses, upholstered divans and upholstered bed bases with flaming types of primary and secondary sources of ignition).

Fire test of mattress according to SS 876 00 10:2001. Measurement of heat release rate and smoke production

Mattress called "Hygienbelagd madrass CMHR".

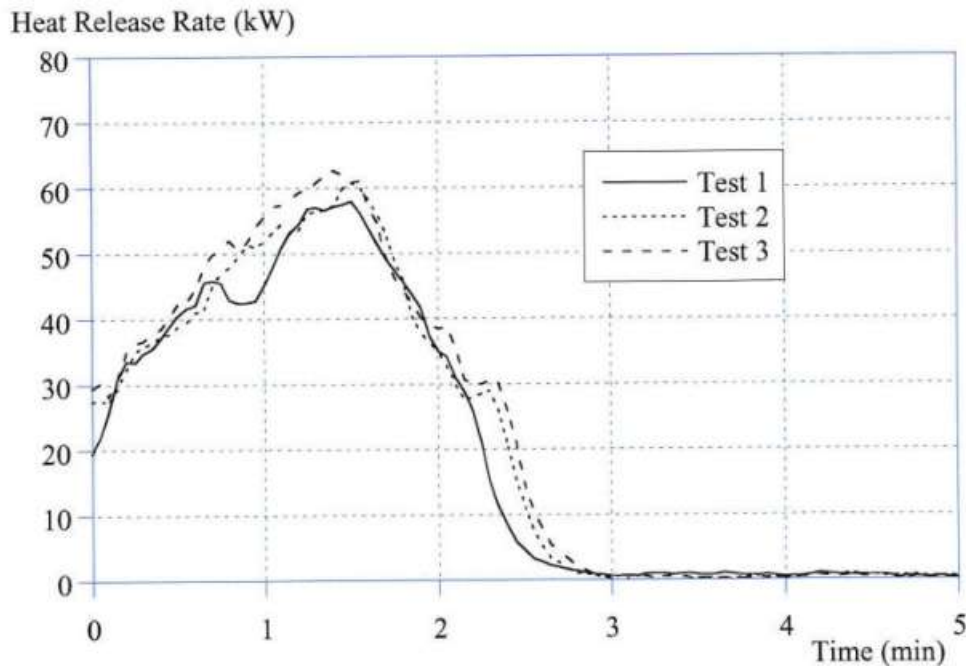
Figure 1 Heat release rate from mattress "Hygienbelagd madrass CMHR" (burner heat output is inclusive).

Test no	1	2	3
Heat release rate, maximum (kW)	58	61	58
Total heat release during testing (MJ)	6,1	6,4	6,1
Smoke production, maximum (m ² /s)	0,7	0,7	0,7
Total smoke production during testing (m ²)	45	44	44
Mass loss during testing (kg)	0,4	0,3	0,3
After burn time, after removal of the burner (min:s)	approx. 0:45	approx. 0:00	approx. 0:33

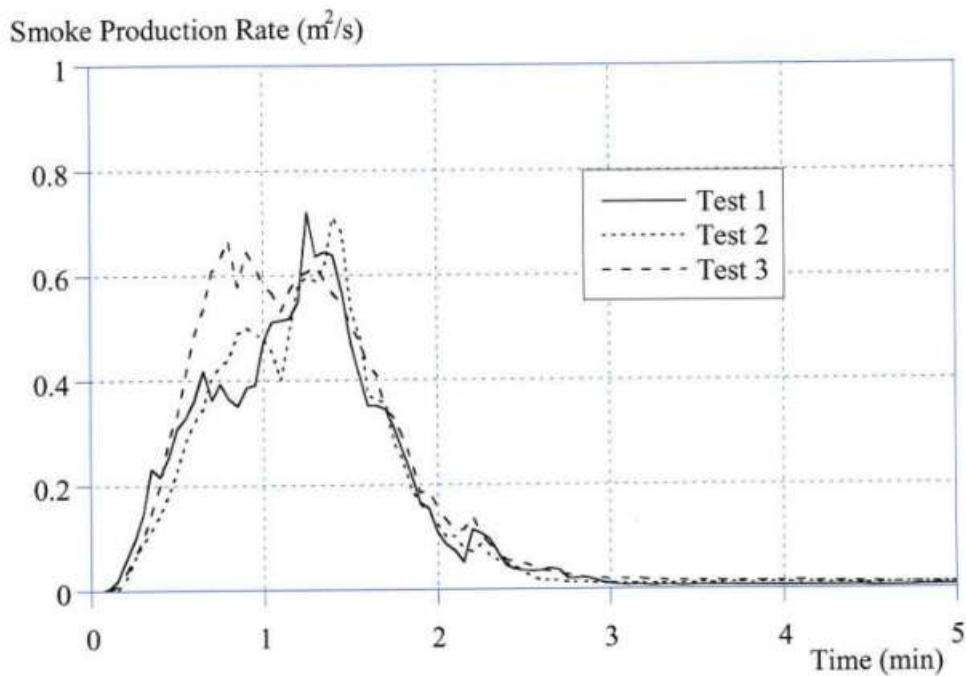
Figure 2 Smoke production from mattress "Hygienbelagd madrass CMHR".

The smoke production rate was calculated according to the following equation:

$$SPR = \frac{1}{L} \cdot \ln\left(\frac{I_0}{I}\right) \cdot \dot{V}$$

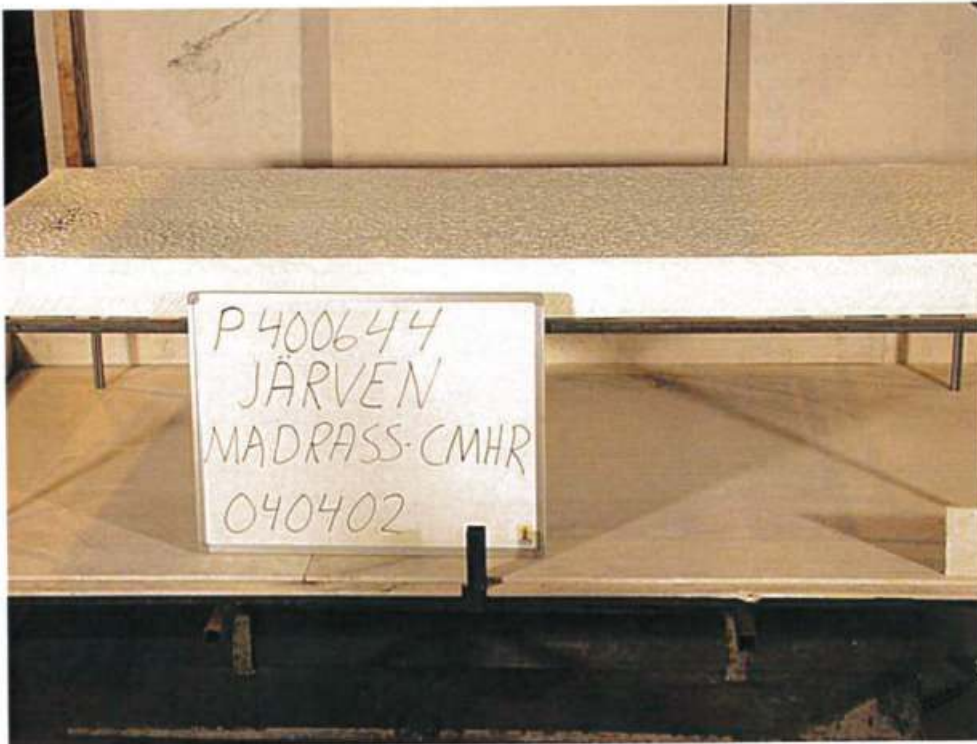
Photo no 1 Prior to test Hygienbelagd madrass CMHR. Test 1.
The mattress is placed on a stand on the scale platform.

The mattress was located on a bed frame of steel profiles that was located on a scale platform. The scale platform had dimension 2.4 x 1.2 m and consisted of non-combustible material, see photo nr 1, 5 and 8.

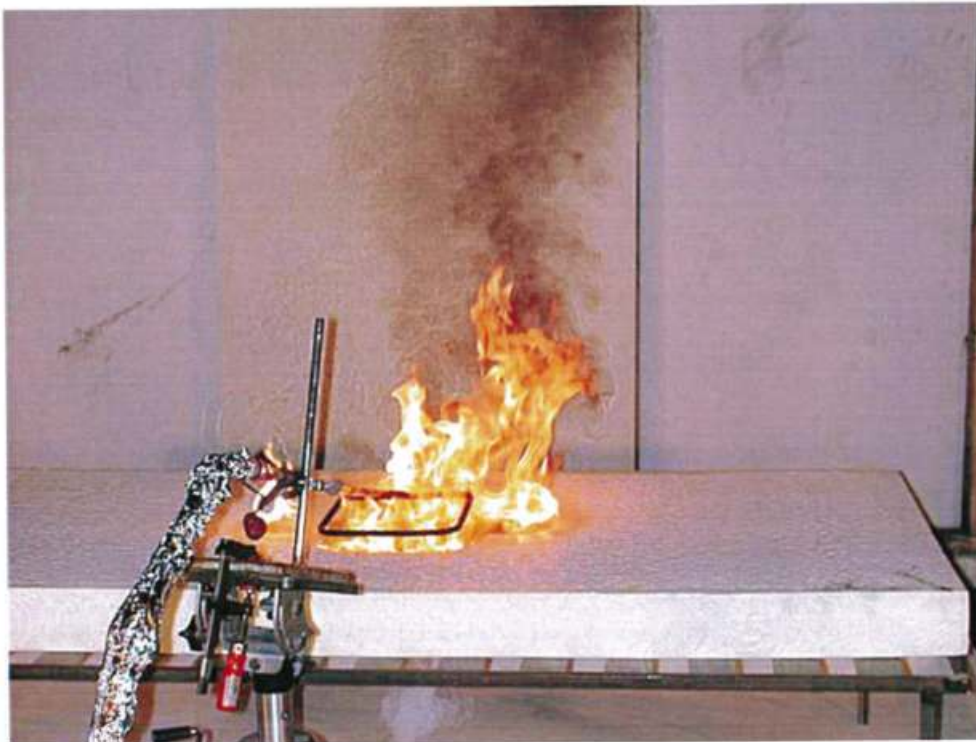
Photo no 2 Time 00:20 (min:s) Hygienbelagd madrass CMHR. Test 1.
The cover and the foam core is ignited by the burner flames.

00:00	The gas burner is ignited. Burner heat output 30 kW.
00:10	The cover melts away in vicinity of the burner.
00:20	The cover and the foam core is ignited by the burner flames, see photo no 2.
00:30	Black smoke production.
00:50	A hole has been formed in the mattress. Droplets of melted material drops down on the platform.
01:07	The melted material on the platform ignited, see photo no 3.
01:35	Flaming from the melted material on the platform ceased.
01:40	Flaming on the mattress surface ceased.
02:00	The burner is removed. A small flame continued to be seen underneath the mattress.
02:45	All flames have ceased.

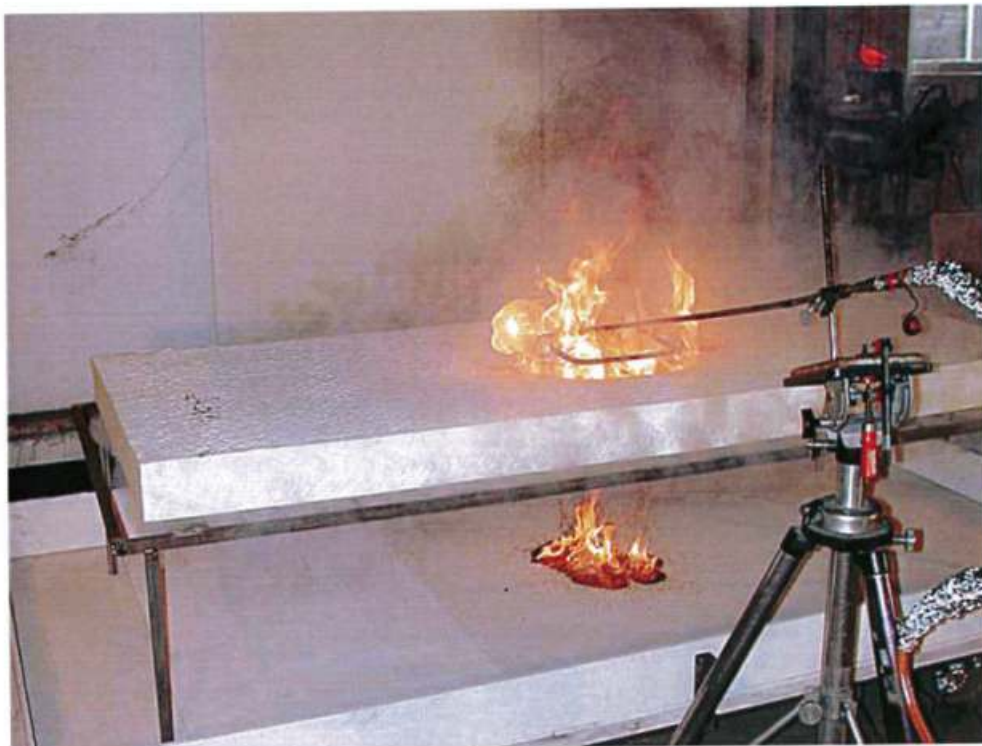
Photo no 3 Time 01:07 (min:s) Hygienbelagd madrass CMHR. Test 1.
The melted material on the platform ignites.

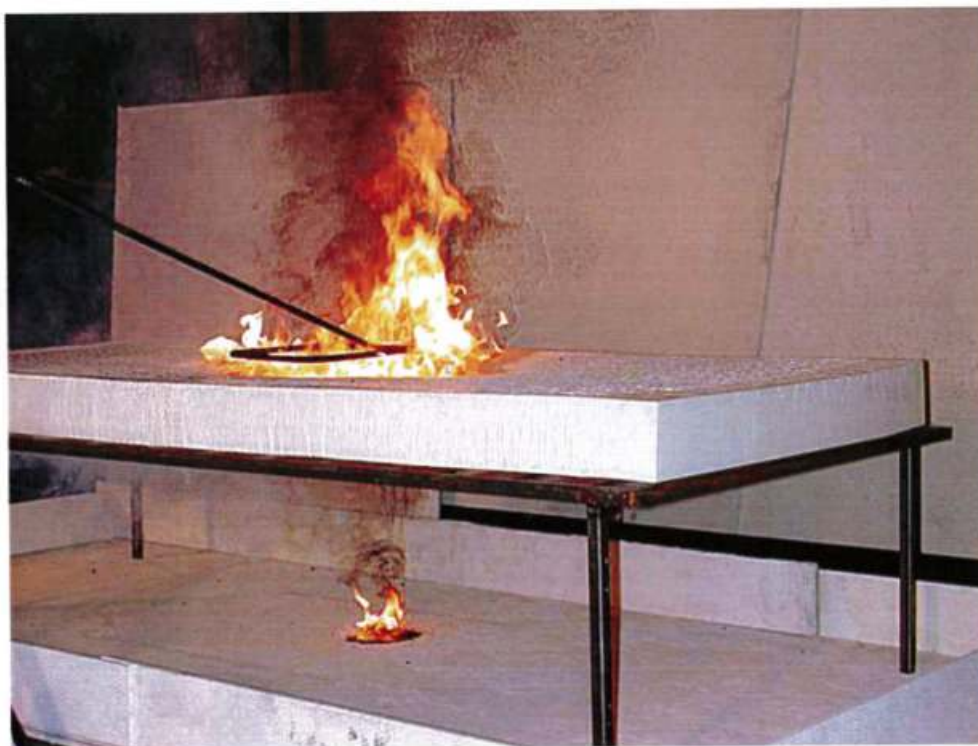
Photo no 8 Time 01:03 (min:s) Hygienbelagd madrass CMHR. Test 3.
The melted material on the platform ignites.

- 00:00 The gas burner is ignited. Burner heat output 30 kW.
- 00:15 The cover and the foam core is ignited by the burner flames.
- 00:25 Black smoke production.
- 00:50 A hole has been formed in the mattress. Droplets of melted material drops down on the platform.
- 01:03 The melted material on the platform ignited, see photo no 8.
- 01:30 Heat release and smoke production decreased, see photo no 9
- 02:00 The burner is removed. Limited flaming in the mattress, see photo no 10.
- 02:14 Flaming from the melted material on the platform ceased.
- 02:33 All flaming has ceased.

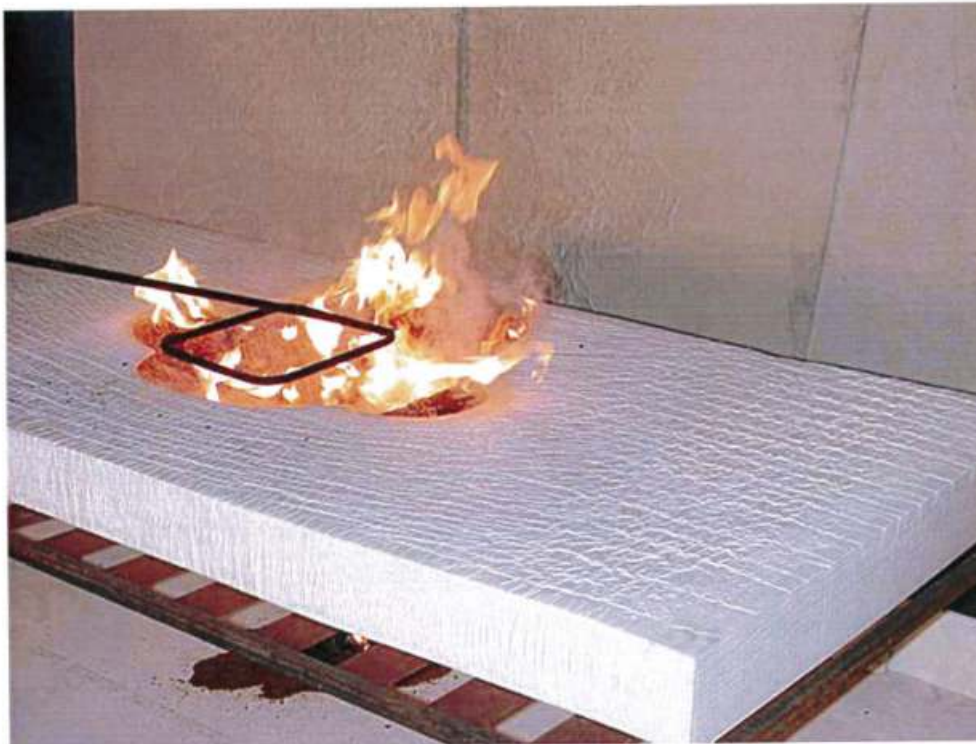
Photo no 9 Time 01:30 (min:s) Hygienbelagd madrass CMHR. Test 3.
Heat release rate and smoke production rate decrease.

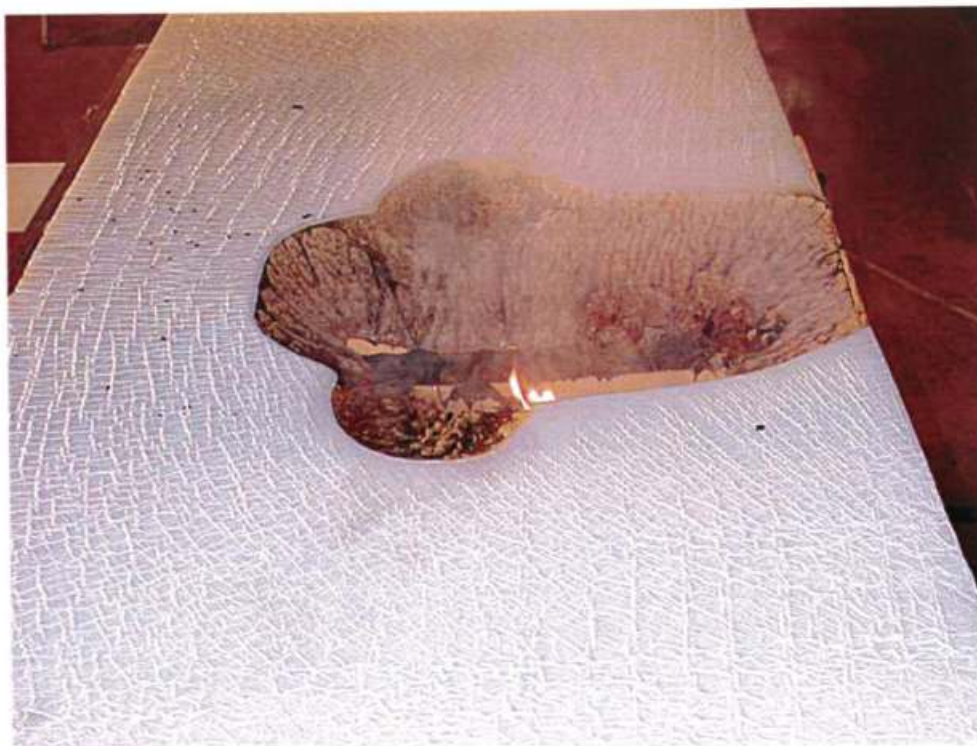
Photo no 10 Time 02:02 (min:s) Hygienbelagd madrass CMHR. Test 3.
Limited flaming in the mattress.
